**SAIB:** 2022-20  
**Date:** October 19, 2022

**SUBJ:** Wing Spar

This Special Airworthiness Information Bulletin (SAIB) alerts all owners, operators, maintenance technicians, and inspectors of **Piper Aircraft, Inc. (Piper) PA-28 and PA-32** airplanes of information gathered as result of a fatal accident of a Piper Model PA-28R-201 airplane in 2018 and the inspection findings that followed. The accident, determined to be caused by fatigue cracks in the lower spar cap, resulted in the Federal Aviation Administration (FAA) issuing Airworthiness Directive (AD) 2020-26-16, which requires several actions including a one-time inspection of certain lower spar cap bolt holes. AD 2020-26-16 was issued as an interim action and requires reporting certain inspection information to the FAA to help determine the number of cracks present in the fleet. The inspection reports received by the FAA thus far indicate the presence of numerous cracks and hole-quality issues in a significant number of airplanes.

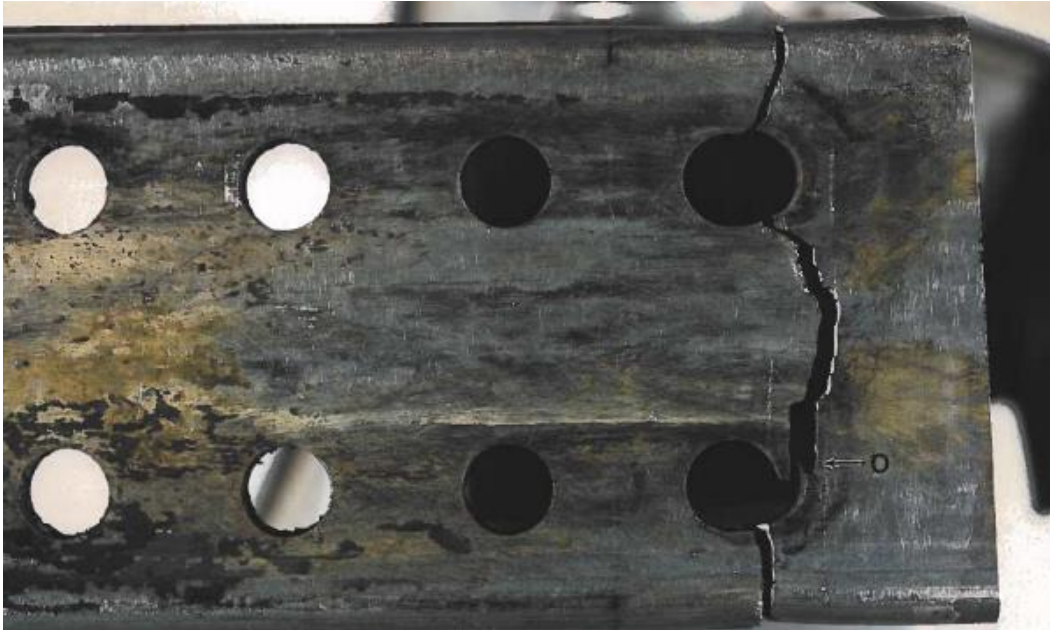
**Figure 4. Example of Cracks Intersecting Outboard Bolt Holes; O indicates crack origin  
PA-28-181, 11,600 hours TIS**

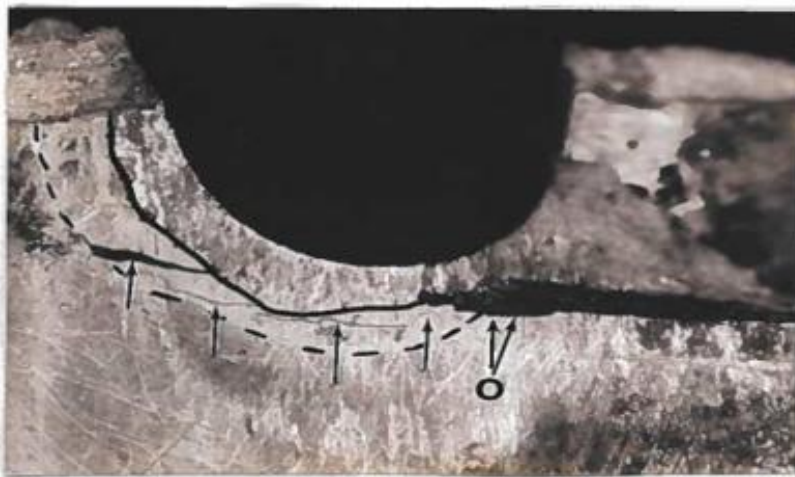
The second of these accidents occurred in 1993 in Provincetown, MA. The accident airplane was a Piper Model PA-28-181 airplane with 11,683 hours TIS. This accident was attributed to weather with signs of structural overloading, but a fatigue crack was also found in the failed spar. The crack is beyond the critical crack size later calculated for that spar. While the NTSB did not identify the fatigue crack as the probable cause of the accident, its presence may have contributed to the effect of the structural overload. At the time of the accident, the airplane was being flown for personal use; however, the airplane was operated by a company providing a mix of training and charter flights. The training mission type of flying is characterized by low altitudes and many takeoff and landing cycles. While less severe than a “Pipeline Patrol” mission, the training mission would contribute more towards fatigue than personal use. See Figure 11 for a view of the accident airplane’s failed spar near a bolt hole, where “O” indicates fatigue crack origins. The origin in this case was adjacent to the hole, not in the hole, as in the 2018 accident.

**Figure 11. 1993 Accident, Failed Wing Spar  
PA-28-181, 11,683 hours TIS; O indicates crack origin adjacent to the bolt hole**
